16 East State Street
(Commercial Building)
Trenton
Mercer County
New Jersey

HABS No. NJ-964

ARCHITECTURAL DATA FORM

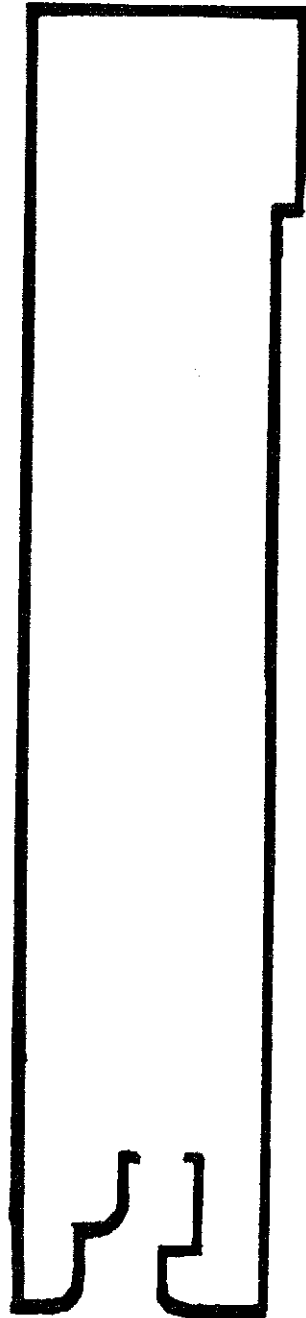
Floor Plan

SHAPE AND DIMENSIONS OF STRUCTURE (SKETCHED FLOOR PLANS ON SEPARATE PAGES ARE ACCEPTABLE) Rectangular structure. Facade=20'. Depth=102.46'.		
EXTERIOR FEATURES OF NOTE Facade is one large bay with centered window wall of grouped sash and fixed panes. Neoclassical moldings, enframing pilasters, modillion cornice and parapet articulate the planar wall surface.		
INTERIOR FEATURES OF NOTE (DESCRIBE FLOOR PLANS, IF NOT SKETCHED) Walls covered with sheetrock, floors with wall-to-wall carpeting. The first floor is a retail space greatly altered over time. The upper floors are divided into front and rear offices.		
MAJOR ALTERATIONS AND ADDITIONS WITH DATES Storefront altered with recessed bulkhead, metal panels and roll-down metal security door, all ca. 3rd quarter 20th century. All historic interior features and finishes removed, date unknown.		
PRESENT CONDITION AND USE Fair to good condition. Retail and office use until demolition, September, 1987.
